Structural Testing of Straw Bales in Axial Compression

**Kristin Field, James Woods, Claudia Fedrigo
CVEN 5838 Final Presentation
April 28, 2005**

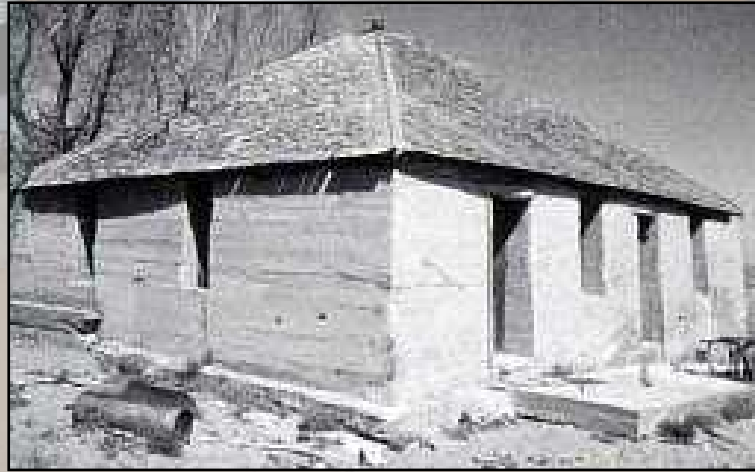
Straw Bale Construction

- **Began ~ 100 years ago in western Nebraska**
- **Utilizes a waste material to construct well insulated walls ~ relatively high R-value**
- **Constructed from large blocks and then rendered or plastered with a finish to weather proof the building**
- **Natural material, no industrial/polluting processes**

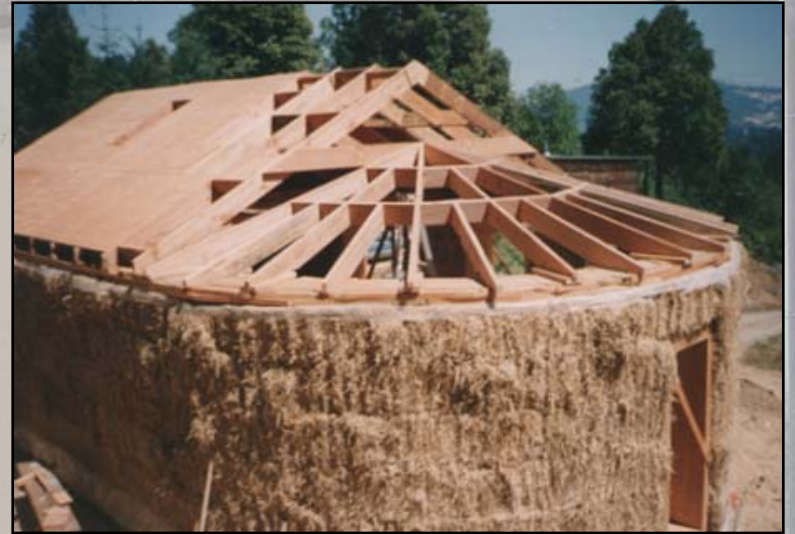
- **Our Project: axial compression tests of straw bales, both plastered and unplastered**
- **This information can prove to local building officials that straw bales can meet and exceed the safety requirements for buildings**

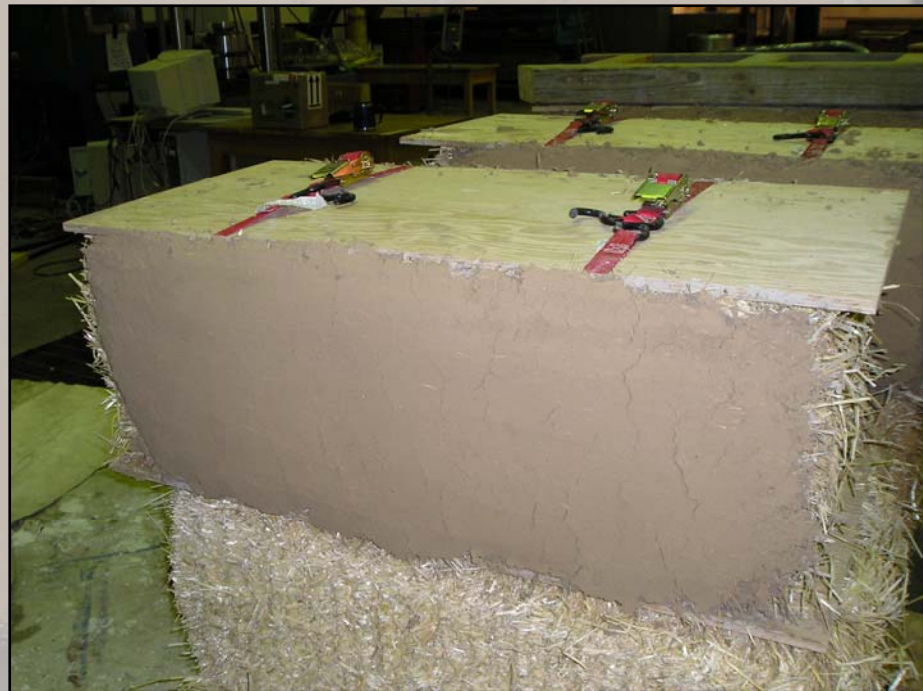
Test Preparation

- **Pre-compress plastered bales**
- **Give bales time to dry**
- **Build wood frame**
- **Obtain metal plates**

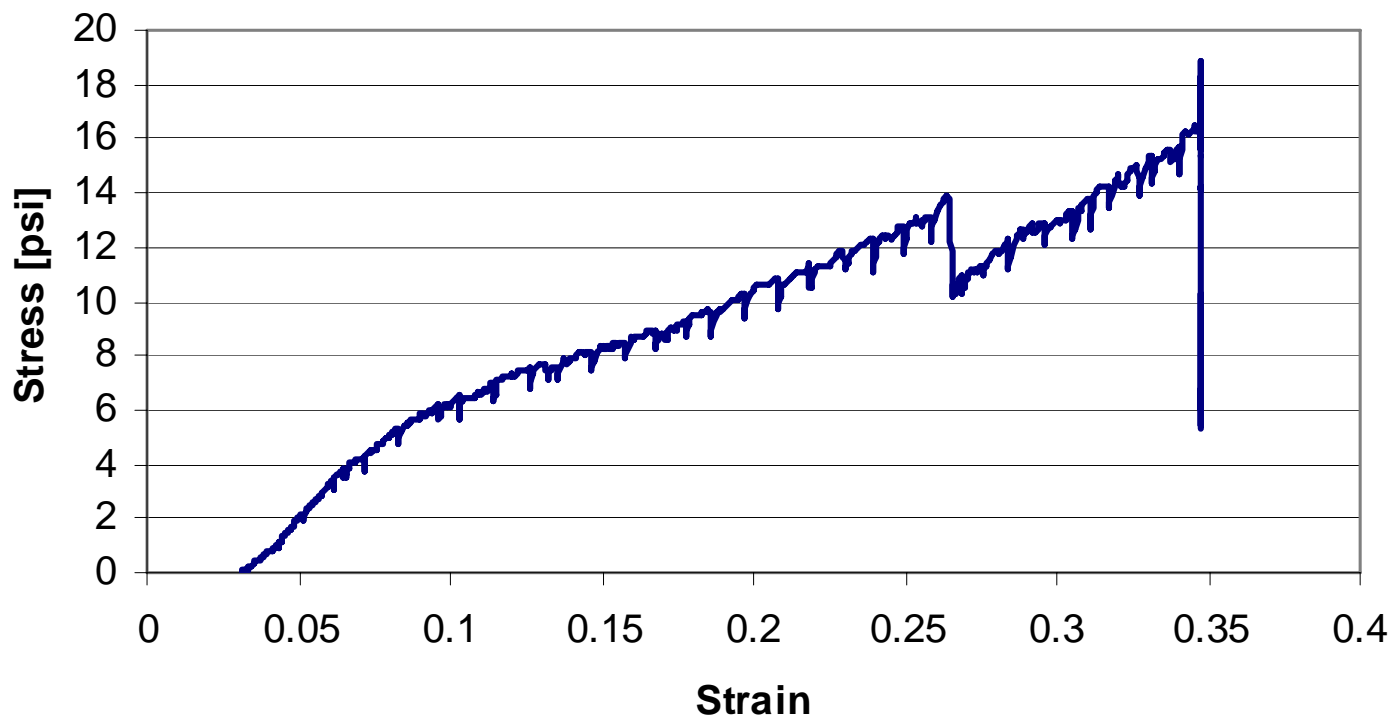
Plastered Bale #2 - Stress Strain Diagram

Bale	E [psi]	Failure Load [kips]
1	44	10.8
2	41	9.9
3	41	9.6
1b	60	14.1
2b	68	18.5
3b	65	7.8

- The load at which the first bale string ruptured is the failure load
- Mostly linear stress strain curves ~ Elastic
- All six bales continued to exhibit elastic behavior even after rupture of a bale string
- Plastered bales performed well below expectations
 - Plastered bales basically expand in two dimensions under compression
 - Increased stress on the bale strings
 - Testing bales vs. a wall
 - Moisture content of the bales

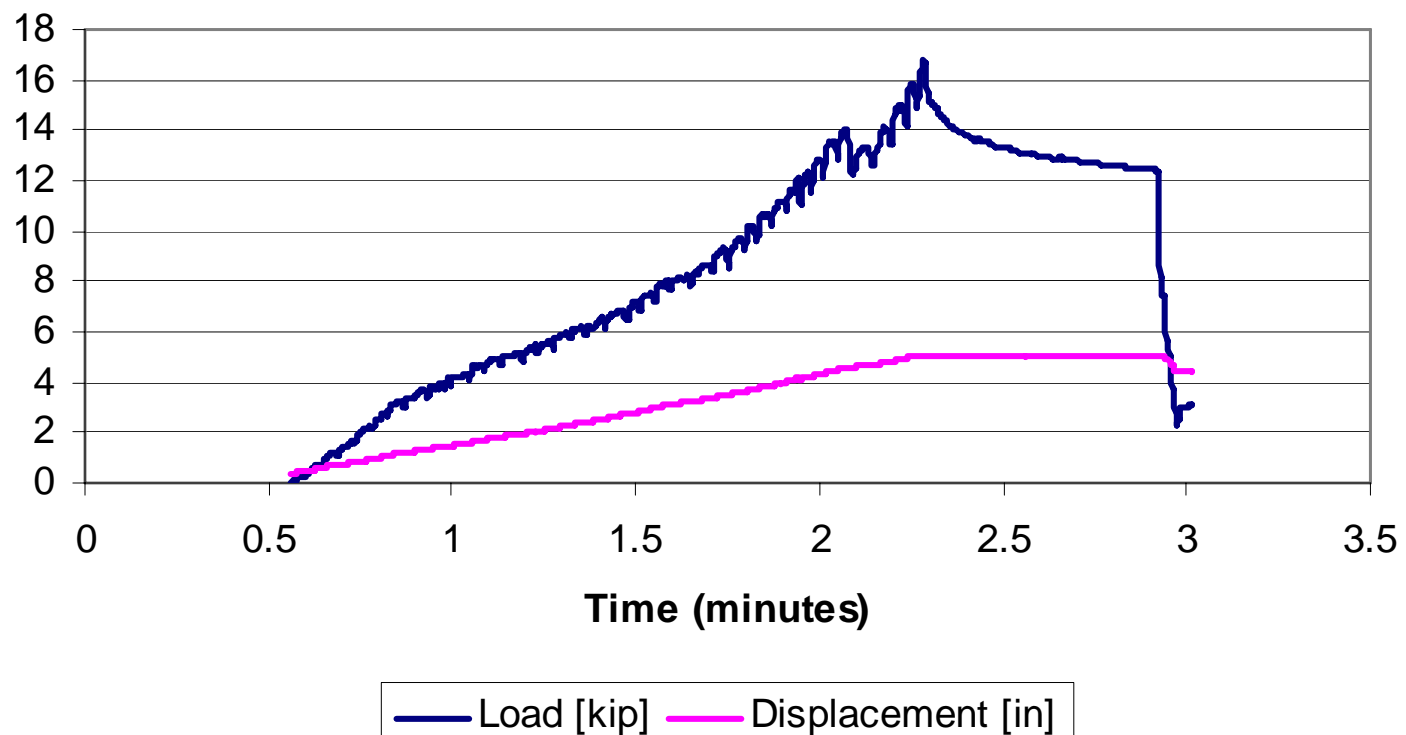
Unplastered Bale #1b - Load and Displacement

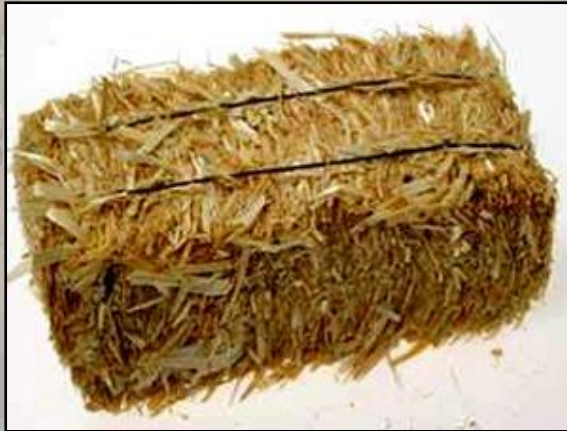
- Thompson ultimate load = 6-10 psi
 - Our “failure” load = 10.8-25.7 psi
- Thompson E = 18-26 psi
 - Our modulus of elasticity = 60-68 psi

- Major differences reflect the potential for variation between different bale sources

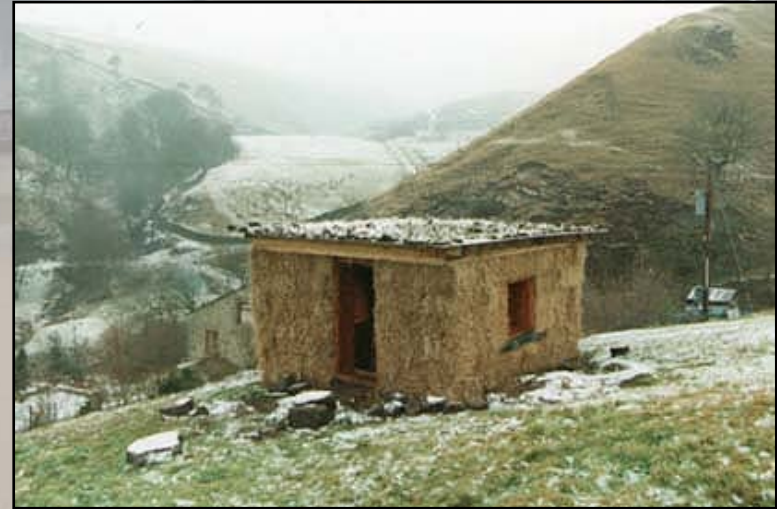
- **Studied structures must support between 636 and 800 plf**
- **Our bales can support approximately 3000 plf**
- **With good test data officials can plainly see how safe a straw bale structure can be**
- **Promote straw bale as an alternative to conventional building materials**
